## Region 5, February 14<sup>th</sup>

On February 14<sup>th</sup> the Engineering Team, together with Mr. Lionel Wordsworth of the Ministry of Agriculture and Mr. Dennis Tahal Regional Engineer Reggion 5 visited Region 5. The site visit was done both by car and boat.

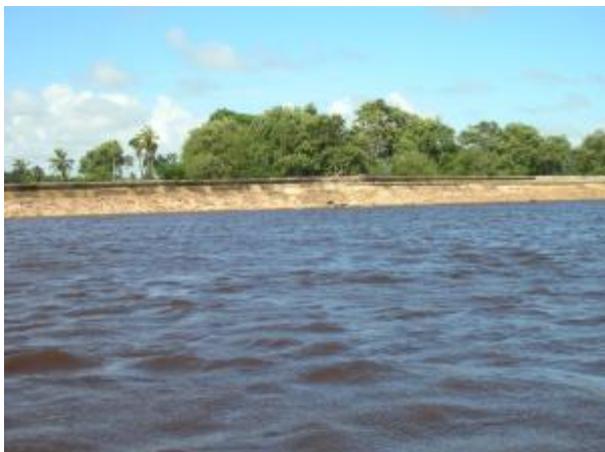
The Mahaica River Mouth is on the west side bordered by a seawall. On the east side mud and sand banks can be noticed.

*Seawall at the river mouth*

1. Dredging of the Mahaica River Mouth (no. 3 on the list of dredging projects)

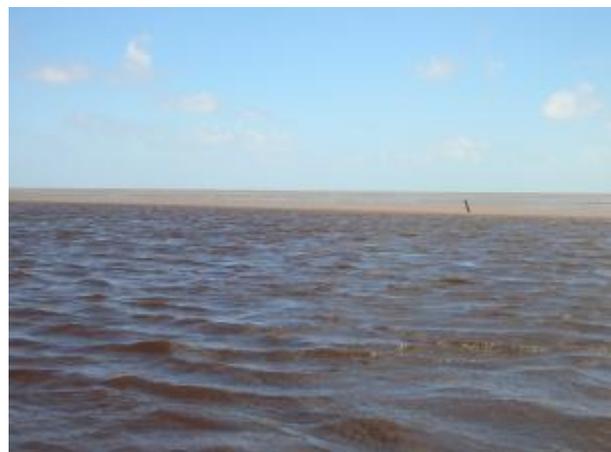
*Sand/mud banks at the river mouth*

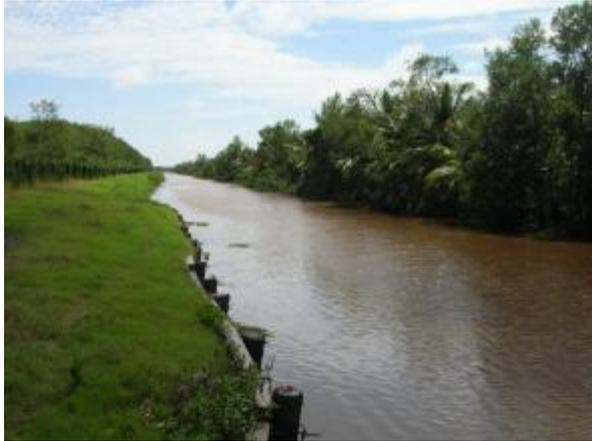
Existing width of the canal is approximately 60 feet. Existing depth of the canal varies between 8 and 12 feet.

Problems of drainage capacity were reported combined with the lack of an embankment between the drain and housing areas. The Ministry intend to extend the width of the canal with another 15 feet. The feasibility of these works could not be confirmed. Between the outfall sluice and the Mahaica river is a short (75 m) section of silted channel.

*Bellamy Canal*

1. Rehabilitation of Bellamy Canal from Mahaicony to Mahaica (no. 45 of the list)

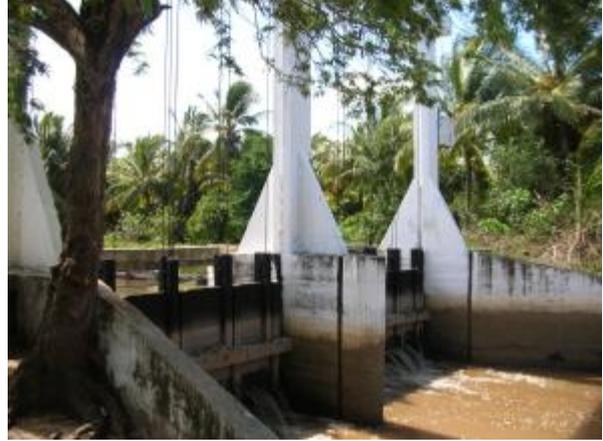
*Bellamy Canal outfall Sluice*

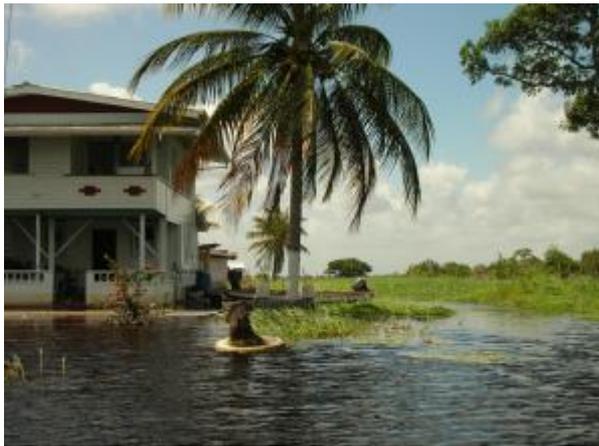
The Mission team visited the Mahaica River stream up by boat. Some of the properties are still flooded.

*Flooded area along Mahaica River*

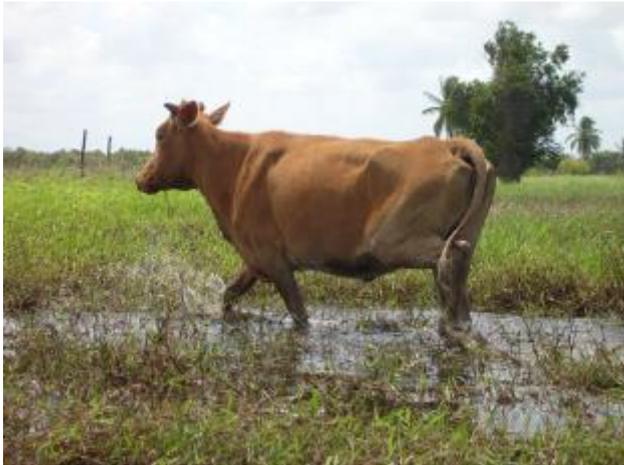
significant flood control. In addition it is reported that cattle farmers cut the embankment to alleviate flooding on their lands to the south.

*Cattle in the swamp*

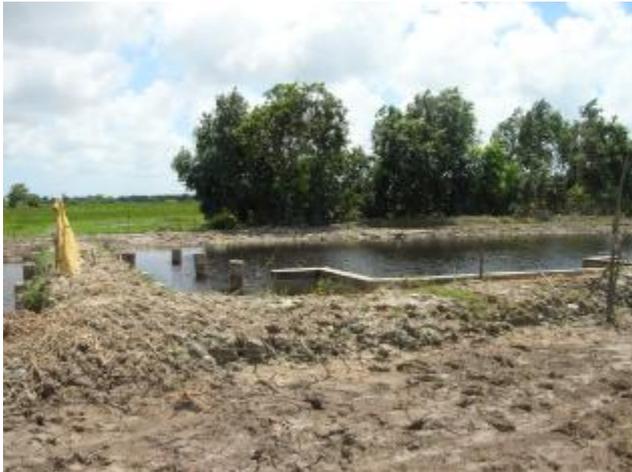
The “Main Canal” heading from the north (Anjou & Hamlet) straight into the swamp normally transports water from the swamp area into the agricultural area. In January a dam closed this main canal preventing the coastal area from extra water out the swamp area.

*Dam, closing the main canal*

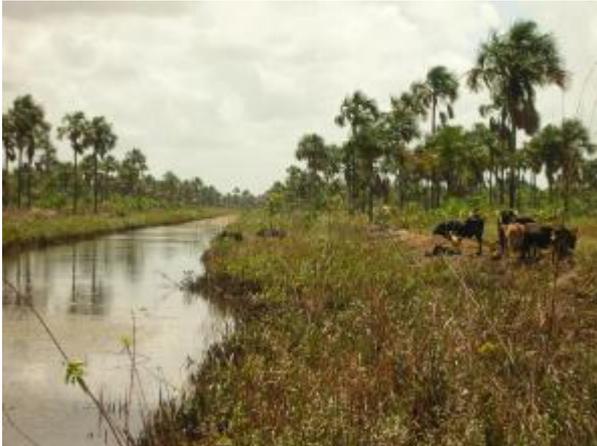
proposed alignment was visited by the mission team. The alignment was chosen to run along a reef of higher ground, which would minimise the height of the embankment, would provide suitable borrow material for embankment construction and would avoid as far as possible deep pegasse soils.

*Area where the Bara Bara Canal is planned  
Perpendicular on the existing Main Canal.*

1. Excavation of Bara Bara Canal from First Depth Mahaicony to Mahaica River and use materials removed from channels to construct a dam between channels (no. 40 of the list).

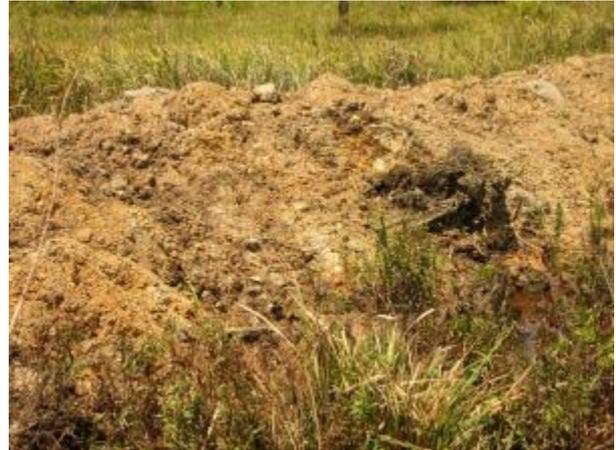
*Pegasse soil, typical for this area*

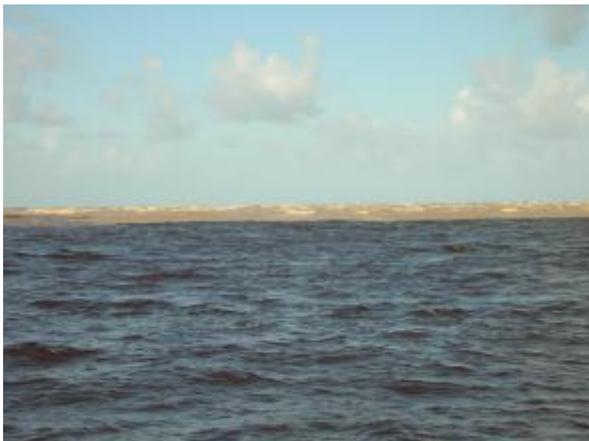
The Mahaicony River enters the Atlantic along a northwesterly alignment with similar sand spit to the Mahaica evident running east to west. There is no known bathymetric survey of the Mahaicony River mouth. No record of previous dredging has been found.

*Muddy shallow water along the coast  
Close to the Mahaicony river mouth*

1. Dredging of the Mahaicony River Mouth (no. 2 on the list of dredging projects)

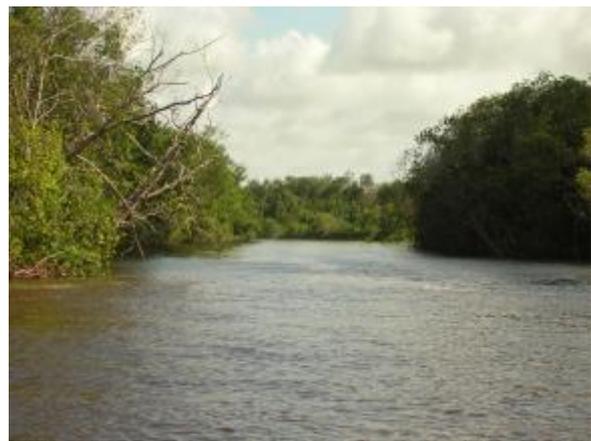
*Mahaicony River Mouth*
