## Engineering Assessment of 2006 Floods

### February 2006

#### APPENDIX 2 SITE VISITS

##### Region 2, February 11<sup>th</sup>

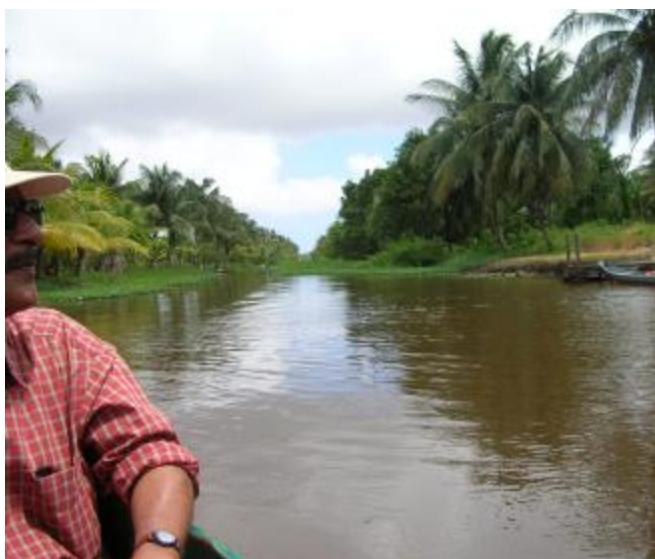
The Cozier/Pomeroon Sea Sluice is not functioning. The result is that water in this region (approximately 8000 Acres) has to be discharged mainly by the Pomeroon River. In case of excessive rainfall water in this area cannot be discharged quickly enough. This will cause flooding.

The width of the canal is estimated at 50 feet. The depth of the canal varies between 4 feet and 12 feet responding to the tide.

*Canal Cozier or Hope & Succes*

1. Desilting of Cozier outfall at Cozier/Pomeroon (no. 1 of the list)
2. Desilting of drainage canals within Cozier/Pomeroon (no. 2 of the list)
3. Rehabilitation of Cozier Pump station/Pomeroon (no. 4 of the list)
4. Rehabilitation of Cozier/Pomeroon Sea Sluice (no. 13 of the list)

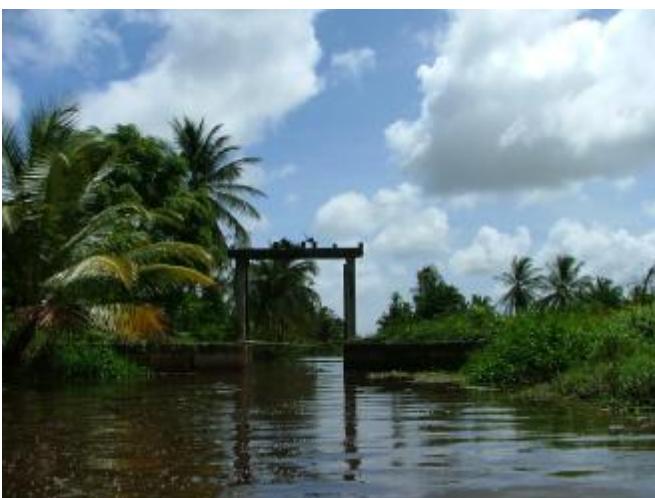
The small canals in this region are to be regulated by small barrages/sl uices. Most of these barrages/sl uices are not functioning properly.

*Small barrage/sl uice*

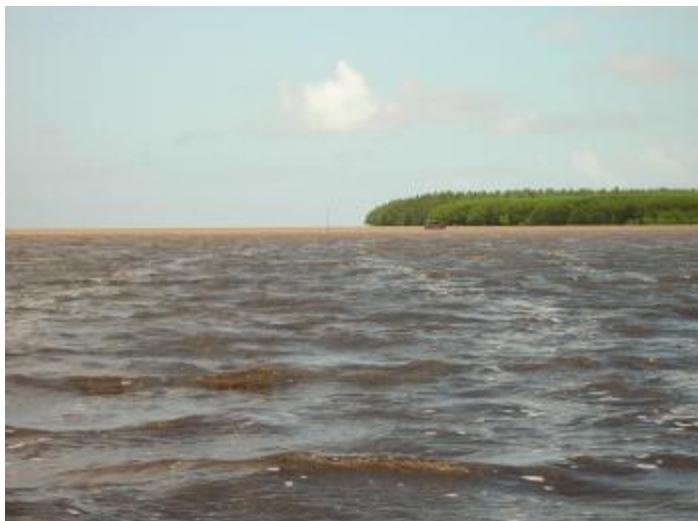
The width of the Pomeroon river mouth is estimated at 200 m.

There are a lot of mud-banks in front of the river mouth.

During low tide its possible to stand at the mud/sand-banks.

*River Mouth with small boat stuck on a sand bank*

1. Dredging of the Pomeroon River Mouth (no. 4 of the list with Dredging works)

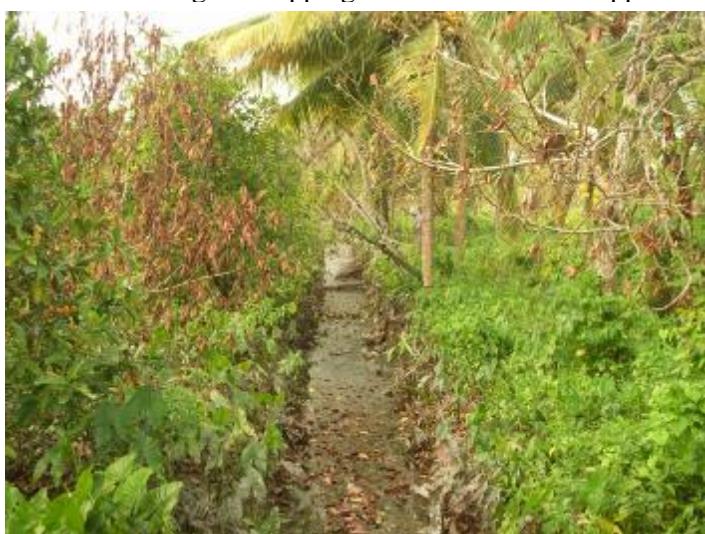
All along the Pomeroon river lands have been flooded for about 4 weeks from the end of December 2005. The water level on the Pomeroon river was the highest one since 1973. Plants and crops were affected, especially cah crops and fruits like coconuts and avocados. Most of the houses are not affected. During overtopping the water level was approximately 30 cm higher than during spring tide.

*Some plants died due to high water (Avocado)*

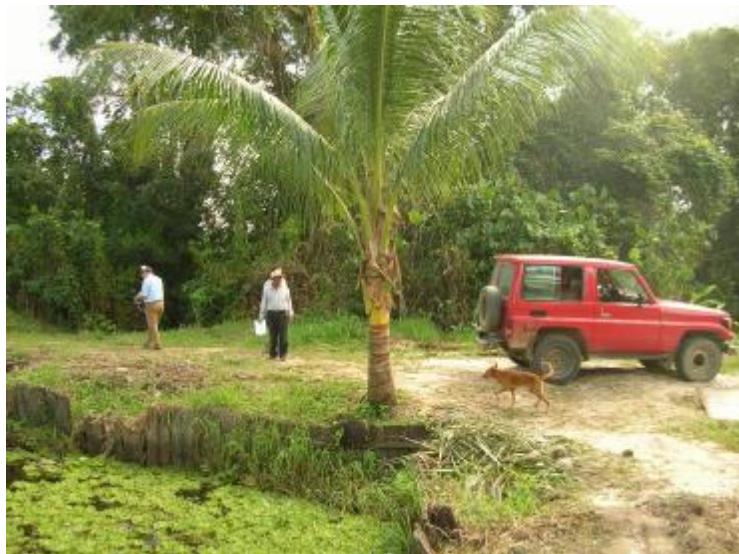
Up to know discharging of water in this region only can be done by using the seawall sluice.

*Proposed location for a new sluice*

Due to the flooding during January 2006 it seems necessary to enlarge the capacity to build a new sluice making it possible to discharge water in the Pomeroon river.

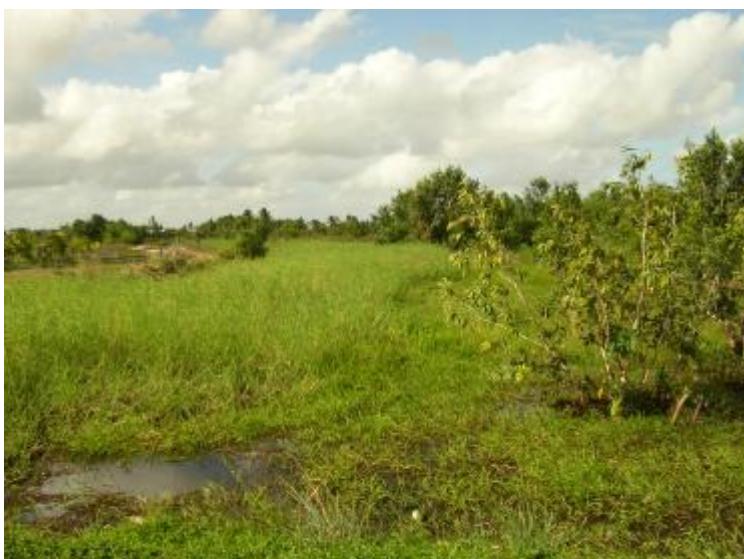
The other works needed to enlarge the capacity of the system is desilting of a canal at Charity. Siltation and overgrowth decreased the capacity of the canal enormously.

*Canal at Charity*

1. Construction of Drainage sluice at Charity (no. 15 of the list)
2. Desilting of canal at Charity (no. 16 of the list)

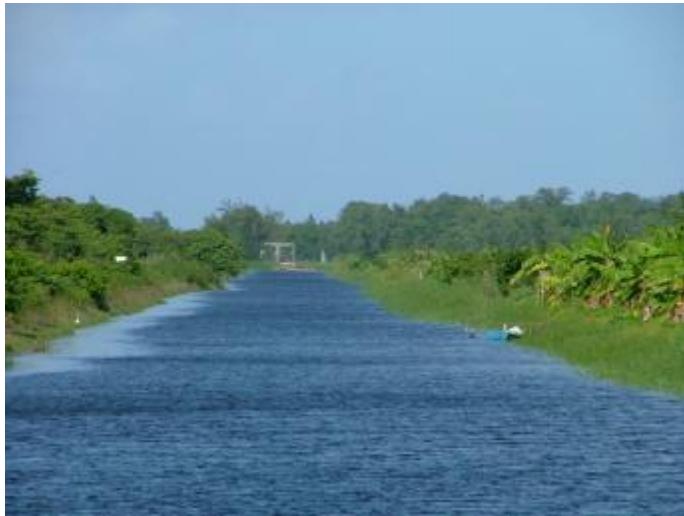
*Canal Somerset and Berks with on the background the relief structure*

1. Widening of relief structure at Somerset and Berks (no. 9 of the list)
2. Construction of Timber revetment at Somerset and Berks Outfall (no. 11 of the list)

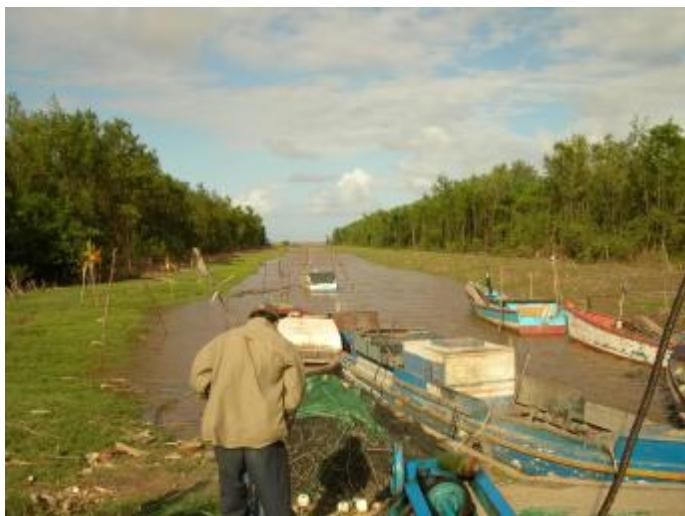
The foreshore at Andrews Outfall has been increasing in the past. At the moment even trees are growing there. At the moment the foreshore is decreasing again. The actual situation prevents a good basis for discharging water. The idea is to narrowing the foreshore canal using timber revetment, which will make discharging more easily.

*Foreshore canal at Andrews Outfall*

1. Construction of timber revetment at Plantation Andrews Outfall (no. 10 of the list)

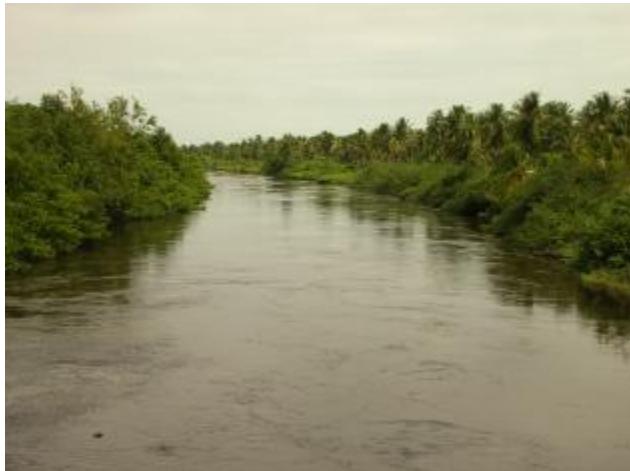
Estimated width 50 m

Estimated depth 7 m

An old bridge, close up stream of the existing bridge forms an obstacle in the river flow.

*Mahaica River, stream down from the bridge*

1. Dredging of the Mahaica Creek Mouth (no. 3 of the list of dredging projects)

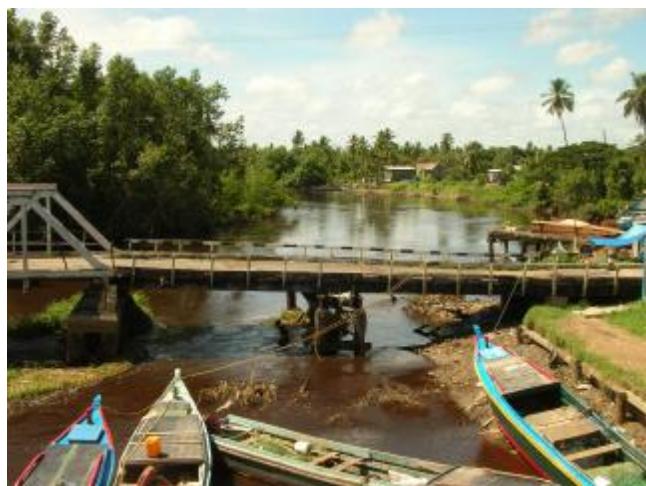
Estimated width 45 m

On the down stream side of the existing bridge an old no longer used bridge forms an obstacle in the river flow.

*Mahaicony River, stream up from the bridge  
with in front the small bridge which gives access  
to town*

1. Dredging of the Mahaicony Creek Mouth (no. 2 of the list of dredging projects)

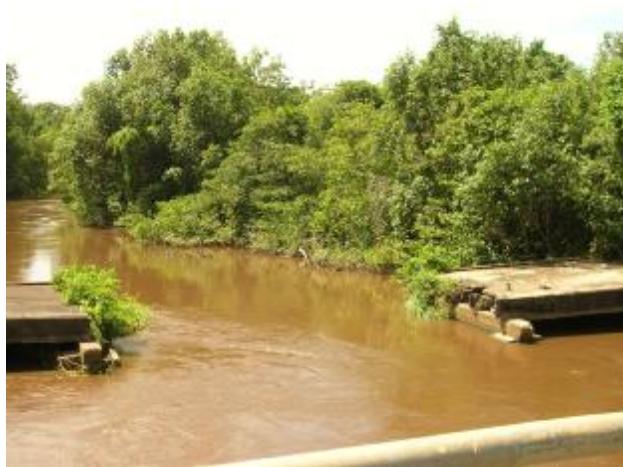
Estimated width 30 m

On the up stream side of the existing bridge an old no longer used bridge forms an obstacle in the river flow. A watermark on this old bridge points 5.3

*Abary River, , stream up from the bridge  
with in front the old bridge*

1. Dredging of the Abary Creek Mouth (no. 1 of the list of dredging projects)

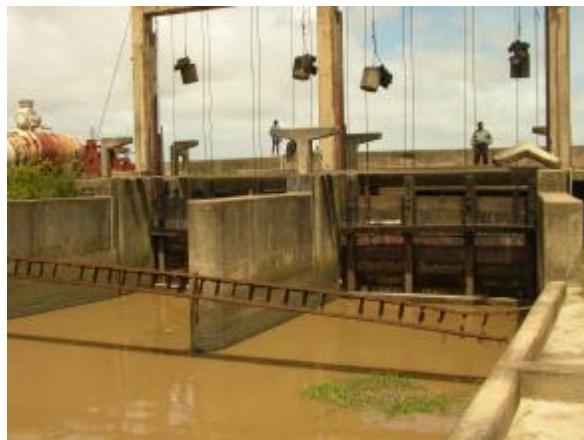
*Landside view on Sluice*

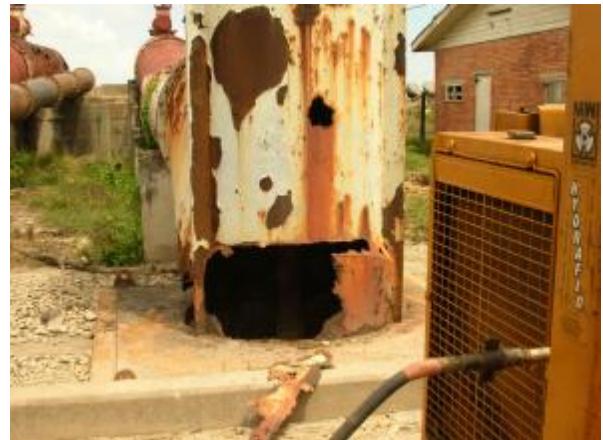
At Trafalgar Pump Station the original pumps (35 years old, 700 cusecs) are dilapidated and are not functioning anymore. These pumps are replaced by new pumps but these new pumps only produce 80 cusecs). The mechanical part of the former pumps and the concrete construction seems to be ok. Especially the pipes and mechanic/electrical part of the pump station is dilapidated.

*Former housing of a pump*

1. Refurbishment of pumps (no. 1 of the MMA list)
